Coal Exchange Report

14 July 2015

Job No	CS/079052		
Project	The Coal Exchange, Cardiff		
Location			
Title	Report on the condition and potential re-use options for The Coal Exchange		
Document Ref		Issue / Revision	
File reference	F:\CAPITA_SYMONDS\Projects\Commercial\CS 079052 Coal Exchange\Report		
Date			
Prepared by 1	Sarah Parr	Signature (for file)	
Prepared by 2		Signature (for file)	
Prepared by 3		Signature (for file)	
Checked by	Chris Wright	Signature (for file)	
Checked by		Signature (for file)	
Authorised by	Derek Russell	Signature (for file)

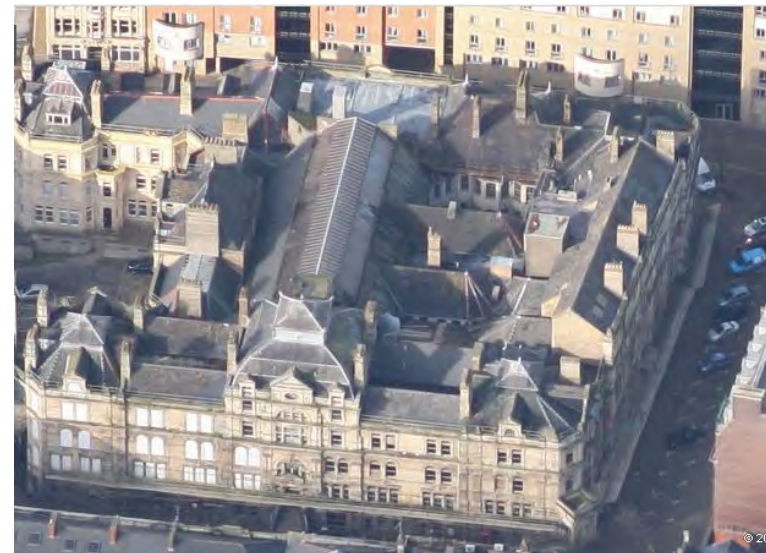
4.5 Roofs

The building has a complex roof formation, made up of pitched roofs with slate and glazed areas and of flat roofs. We were unable to inspect the roof during our visual inspection due to unsafe access. Where we have made comment on the condition of the roof, we have used information from previous reports.

- Nail fixings have corroded in many locations.
- Weathered and loose pointing to ridge and hip tiles evident on all roofs.
- Cracked and loose ridge and hip tiles.
- Delaminating slates.
- Lack of felt below the slates in many areas.
- Insufficient sized tiling fillets at eaves and valley gutter locations.

- Poor lead detailing between glazed panels corresponding with areas of staining and leaks internally.
- Evidence of numerous patch repairs, not all successful.

- Flat roof on west elevation constructed in bitumen felt over a timber decking. In poor condition with split and blistered areas, allowing continued water penetration.

- Lead lined parapet gutters in a poor condition, with areas that have been patch repaired with bitumen felt and bitumen coatings.
- Rainwater outlets and downpipes are blocked causing a back up of water in the gutters and a continued overflow of water down the face of the building in the areas around the blocked and leaking gutters.
- Water staining internally below the outlets and gutters indicate continued leakage.

- Chimney stacks are all in a poor state of repair.
- Excessive weathering of the mortar joints to the stacks, resulting in loose stones and bricks.
- Many stacks have extensive vegetative growth in the recessed joints.

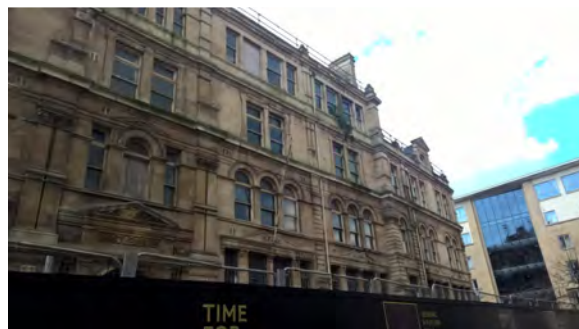
4.8 North West Wing

Access to this area was on the ground floor as all other floors were unsafe to enter. Combining our findings and previous reports, we can provide the following overview of the area.

- There has been a total collapse of floors at first and second floor level, which has caused damage to the walls in the process and resulted in a lack of restraint of the walls.
- Floor areas around the north-west wing have been propped in instances of partial floor collapse. These floors are still suffering from continued damage from water penetration.
- The facade is showing signs of settlement.
- Many of the accessible roof timbers in this area are rotten and have lost their structural integrity. Rotten timber lintels are no longer providing support to the roof trusses.
- Areas of stress to the window jambs have caused the facade stone to split, allowing water penetration and cracks to progress in size due to the free-thaw action.
- Action is required to protect this area from collapse.

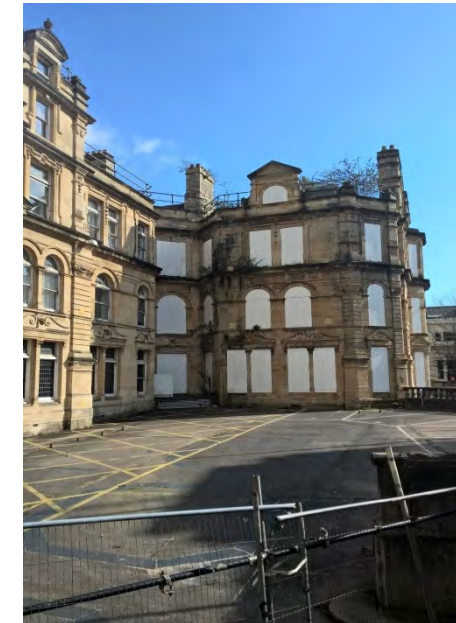
4.9 South East Wing

This area is in a critical condition and access was extremely limited due to the unsafe condition of the area. With our own findings in combination with previous reports we can provide the following overview below.

- Floors at all levels have collapsed, resulting in removal of lateral restraint over the full height of the wing.
- The structural loads have been transferred to the outer decorative leaf of stone, causing the window heads and jambs to split.
- The west elevation of the south-east wing is exhibiting signs of immediate instability, as there is no structure tying the masonry back to the main structure.
- There is damage to the stone facade from falling masonry and evidence of masonry on the ground during our inspection.

- Action is required to protect this area from collapse.

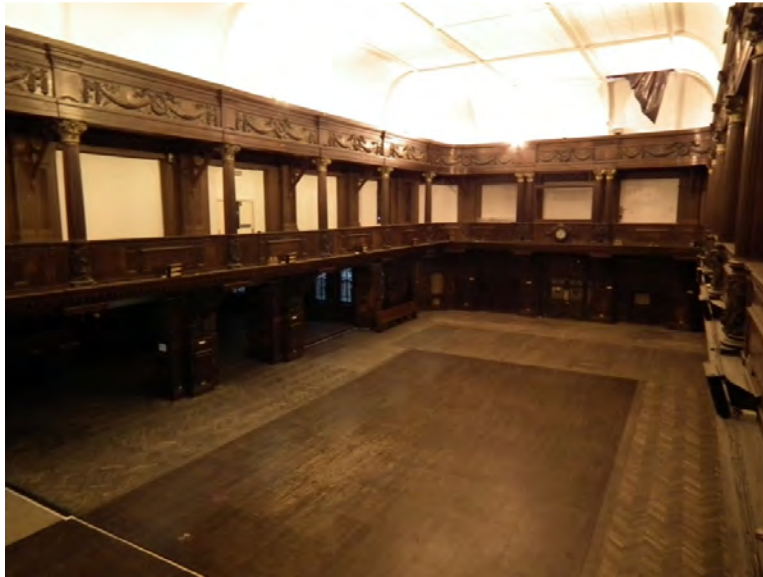
4.10 Main Hall

The main hall on the ground and first floor is in a reasonable condition in comparison to other areas of the building, with localised areas of repair required. However, the condition deteriorates as the building moves up to the second floor and the glazed roof area. This deterioration will eventually feed down through to the currently less impacted areas, so a/an holistic approach needs to be taken / adopted.

The ante rooms are also in a reasonable condition on the ground floor, however the condition deteriorates further up the building. There has been a total collapse of floors in areas on the second floor and evidence of continued water ingress. Again, an approach to address the roof and damaged areas above the ante rooms will be required to prevent the deterioration migrating down to the ground floor.

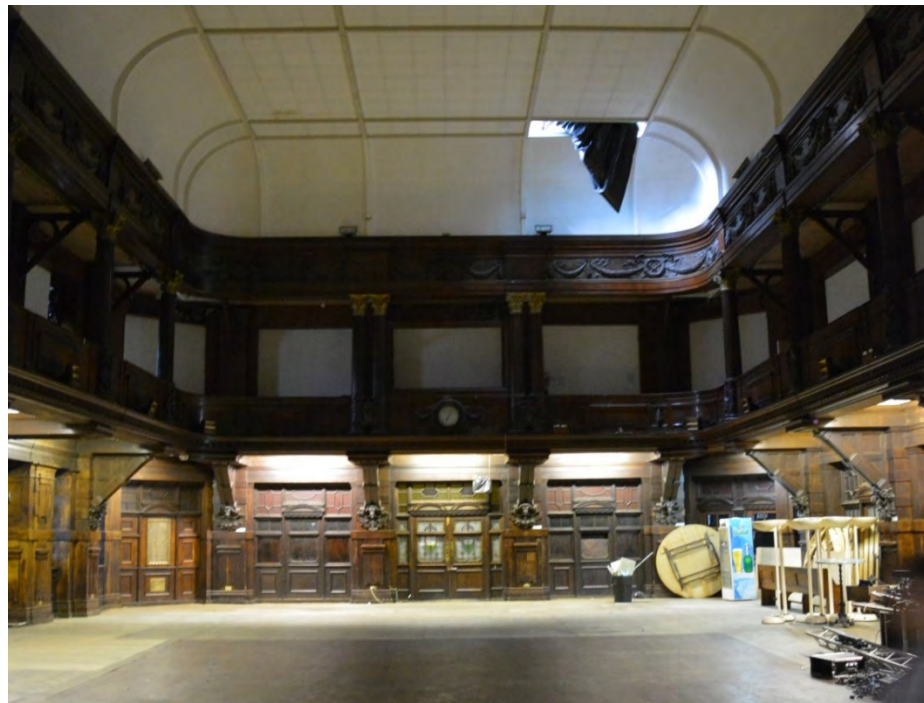
THE EXCHANGE FLOOR IN 2014

From 1961 to the present time some unsympathetic alterations have been carried out, including the insertion of a false acoustic ceiling above the exchange floor in the 1970s, so hiding the upper level gallery and the roof trusses. Also the ruination of the entrance courtyard with an underground car park.

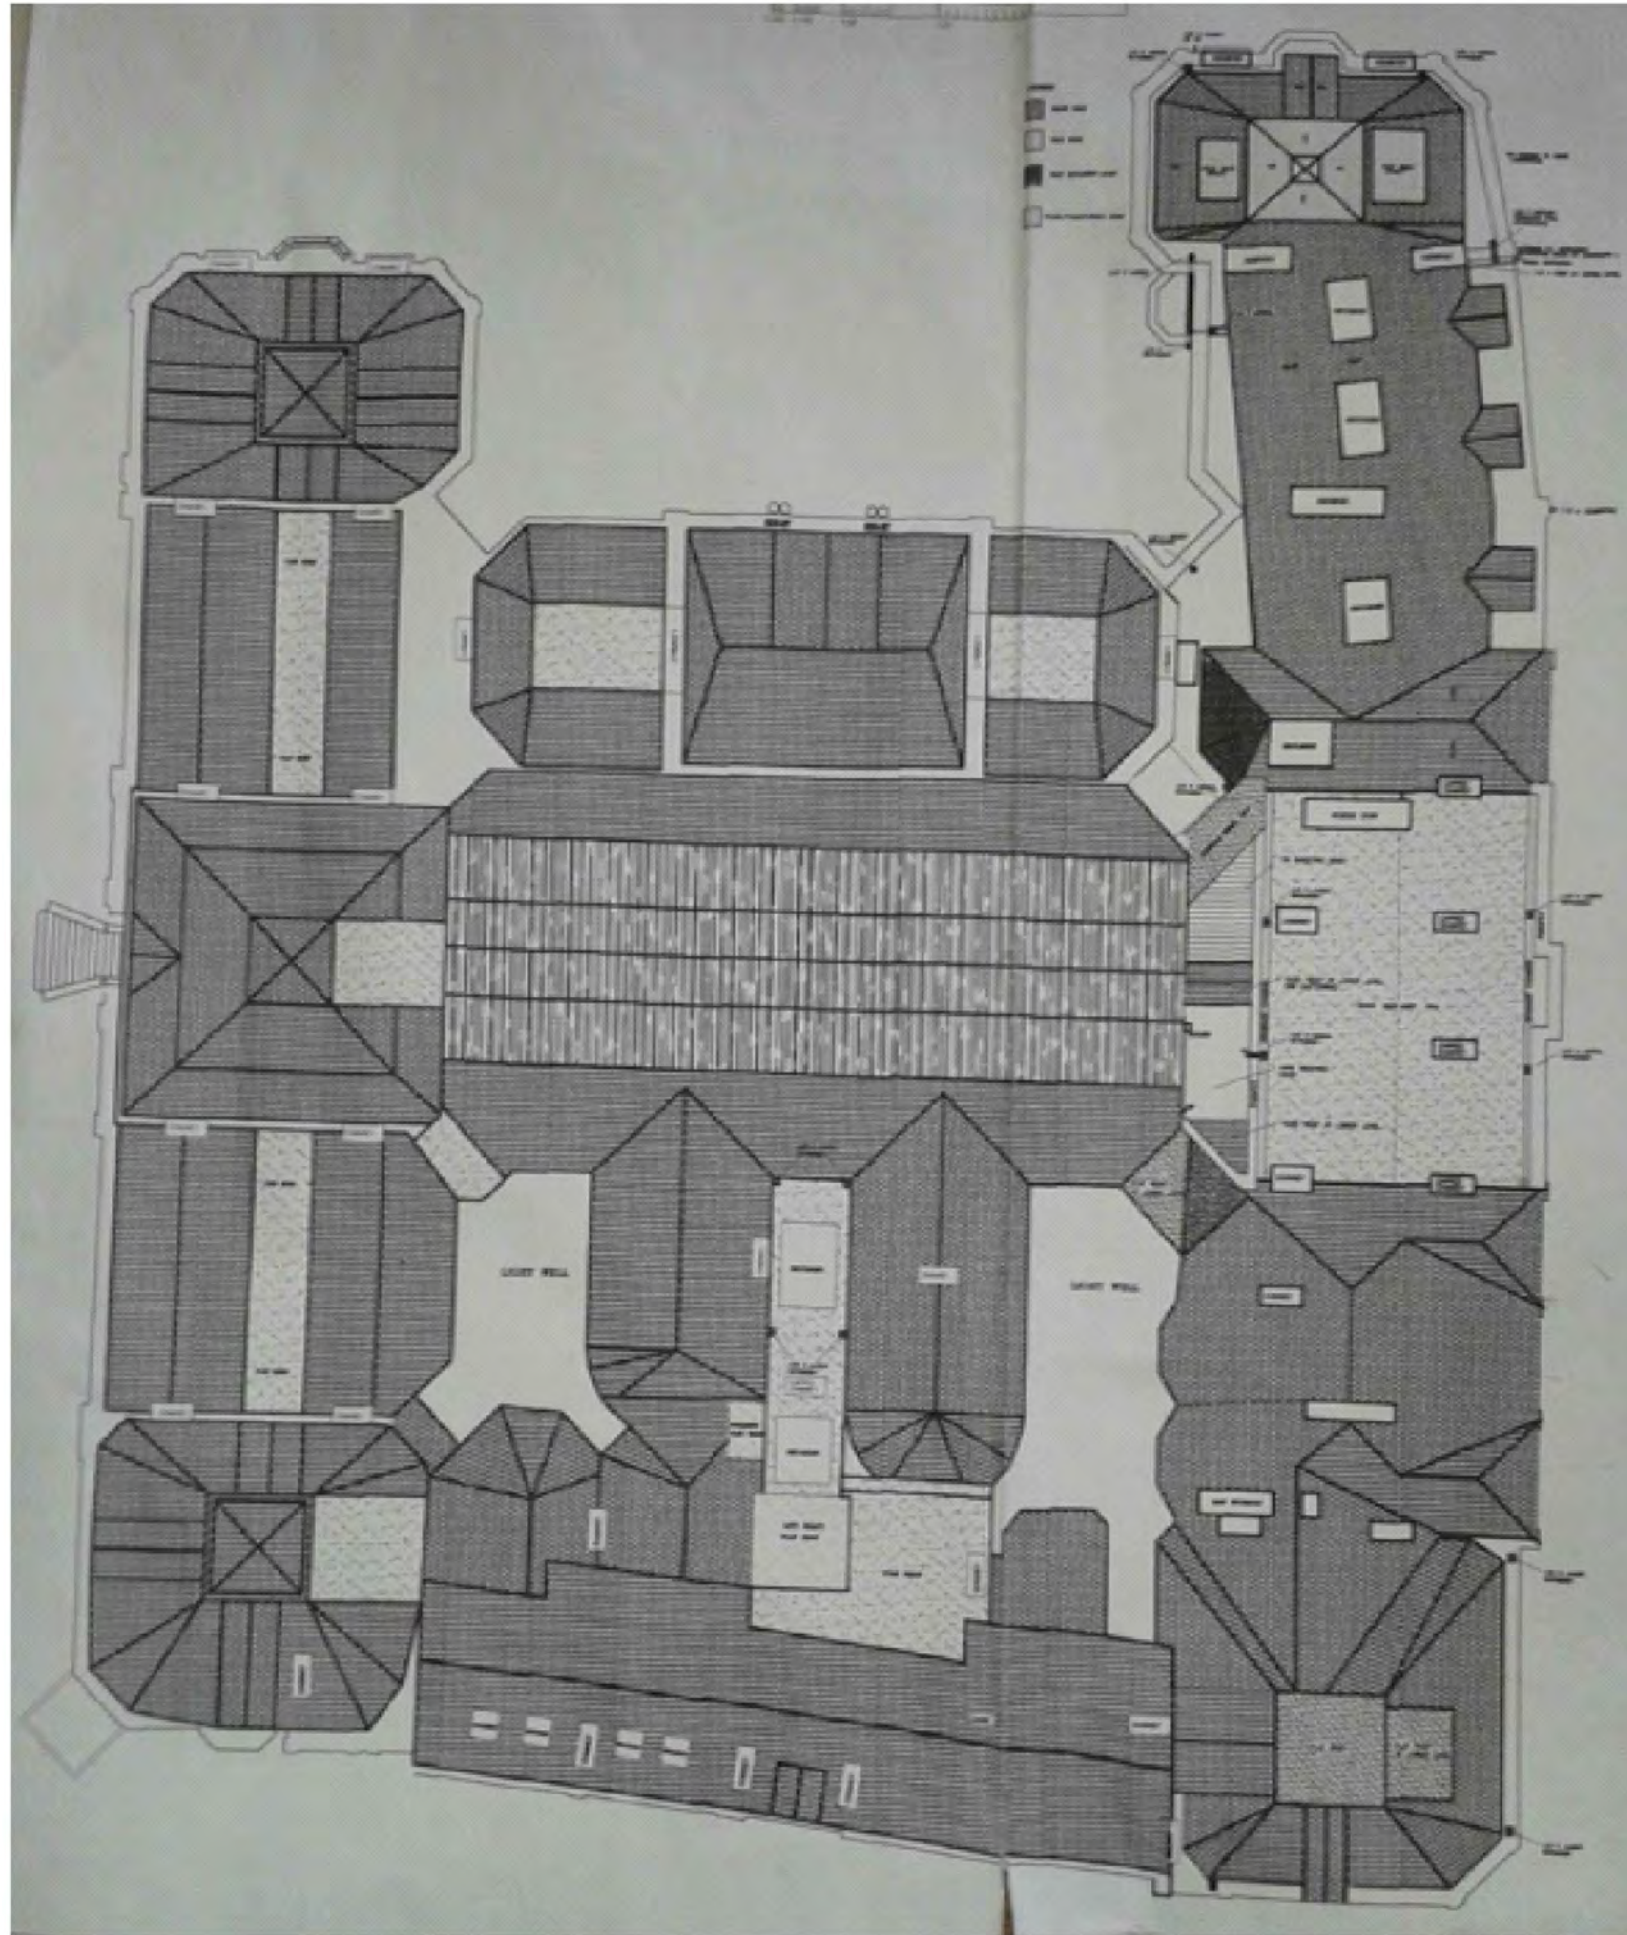
Client			
Welsh Government			
Project			
Coal Exchange Feasibility Study			
Drawing		Drawing no.	
Roof		CE/C06	
Scale @ A3	Drawn	Checked	Approved
NTS	SP		
Project No.		Date	
CS/079052		02/06/2015	
BS1192 Compliant rev

All roof areas were not accessed due to dangerous structure
