Coal Exchange Report

14 July 2015

Job No	CS/079052		
Project	The Coal Exchange, Cardiff		
Location			
Title	Report on the condition and potential re-use options for The Coal Exchange		
Document Ref		Issue / Revision	
File reference	F:\CAPITA_SYMONDS\Projects\Commercial\CS 079052 Coal Exchange\Report		
Date			
Prepared by 1	Sarah Parr	Signature (for file)	
Prepared by 2		Signature (for file)	
Prepared by 3		Signature (for file)	
Checked by	Chris Wright	Signature (for file)	
Checked by		Signature (for file)	
Authorised by	Derek Russell	Signature (for file)

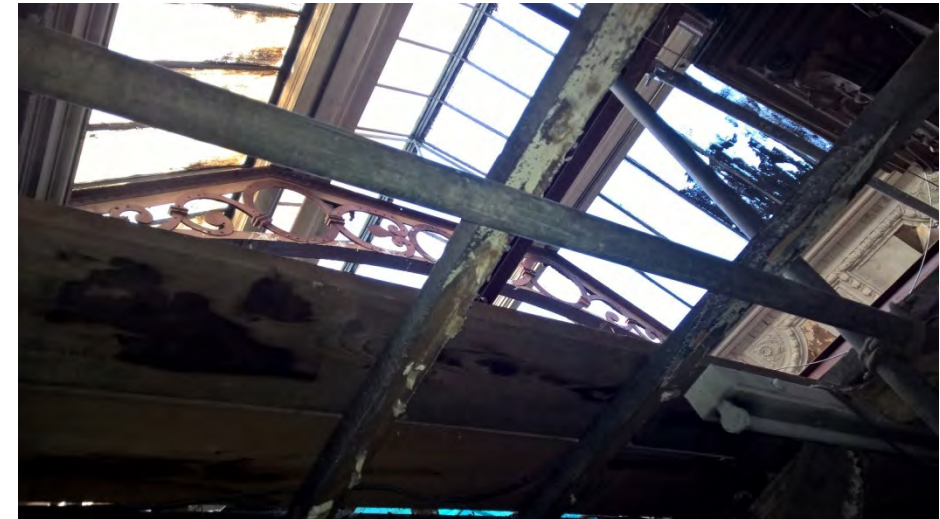
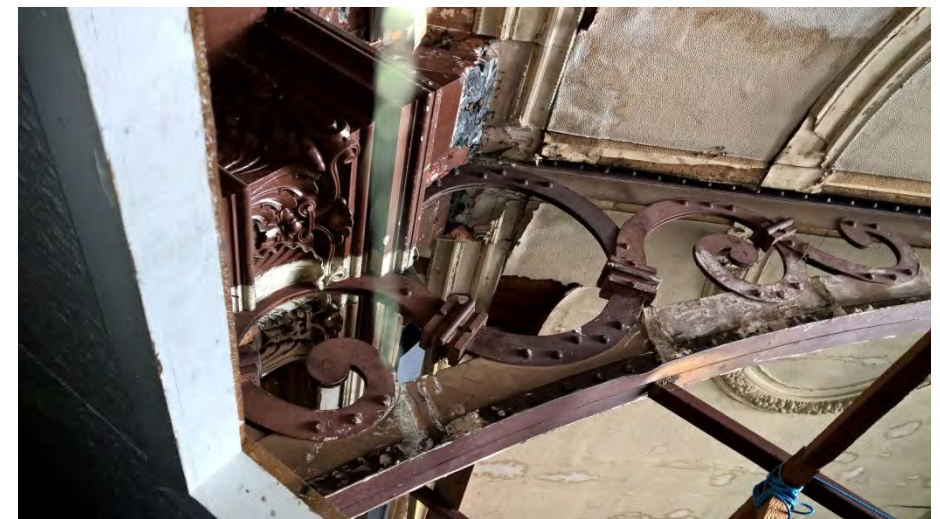
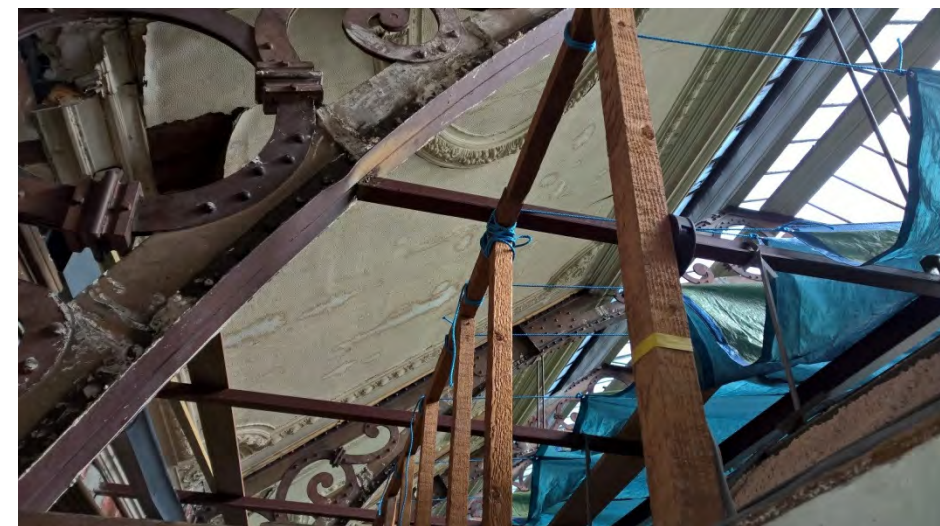
The main hall on the ground and first floor is in a reasonable condition in comparison to other areas of the building, with localised areas of repair required. However, the condition deteriorates as the building moves up to the second floor and the glazed roof area. This deterioration will eventually feed down through to the currently less impacted areas, so a/an holistic approach needs to be taken / adopted.

The ante rooms are also in a reasonable condition on the ground floor, however the condition deteriorates further up the building. There has been a total collapse of floors in areas on the second floor and evidence of continued water ingress. Again, an approach to address the roof and damaged areas above the ante rooms will be required to prevent the deterioration migrating down to the ground floor.

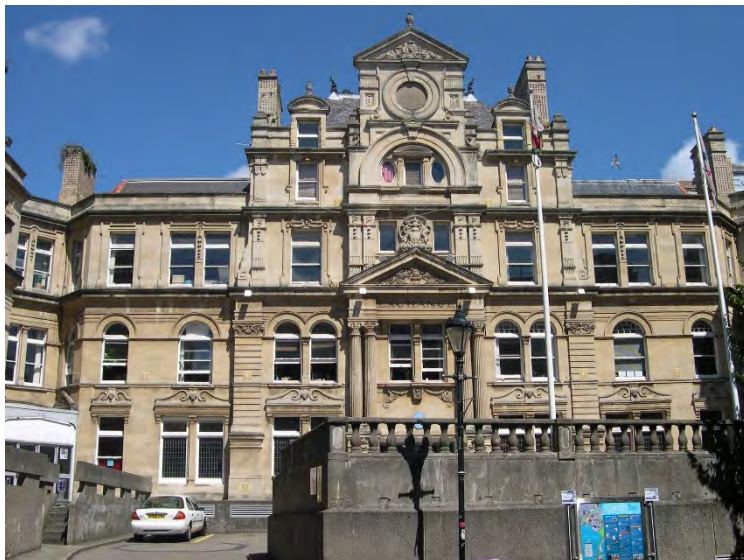
The Front forecourt in 2005

The 1970s car park in the main forecourt to the building was originally designed in concrete in the brutalist style of the period. In the late 1980s attempts were made to soften it outline by building of a false 'georgian' balustrade around the roof in cast concrete. Disregarding at this stage the aesthetic imperfections, the whole structure compromises all opportunities for both returning the forecourt to its original state and also creating ramps and steps that are DDA compliant.

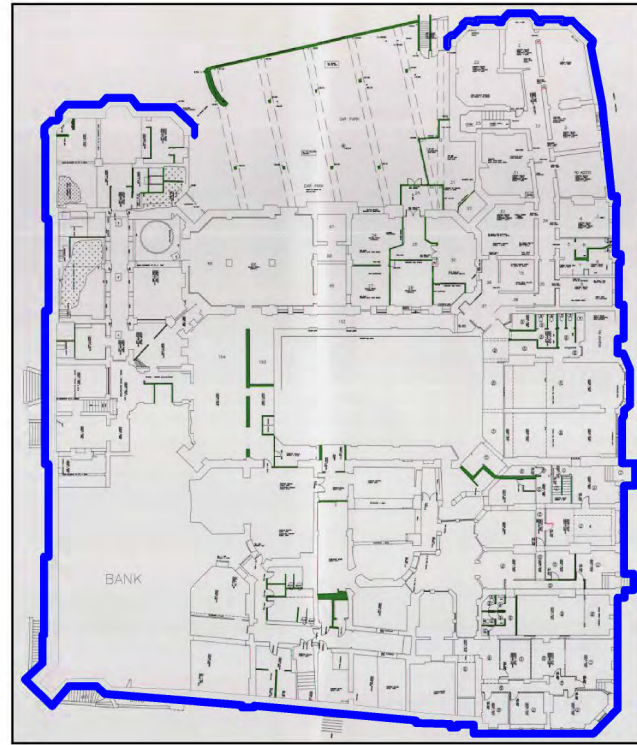
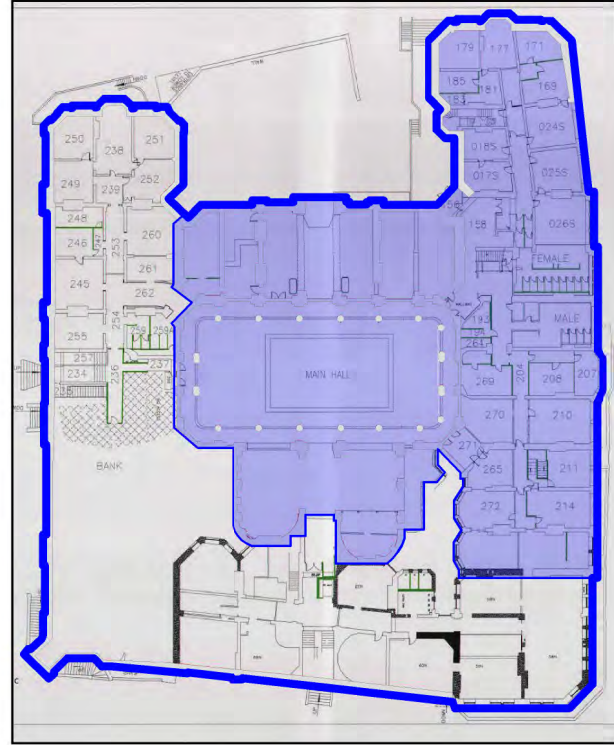
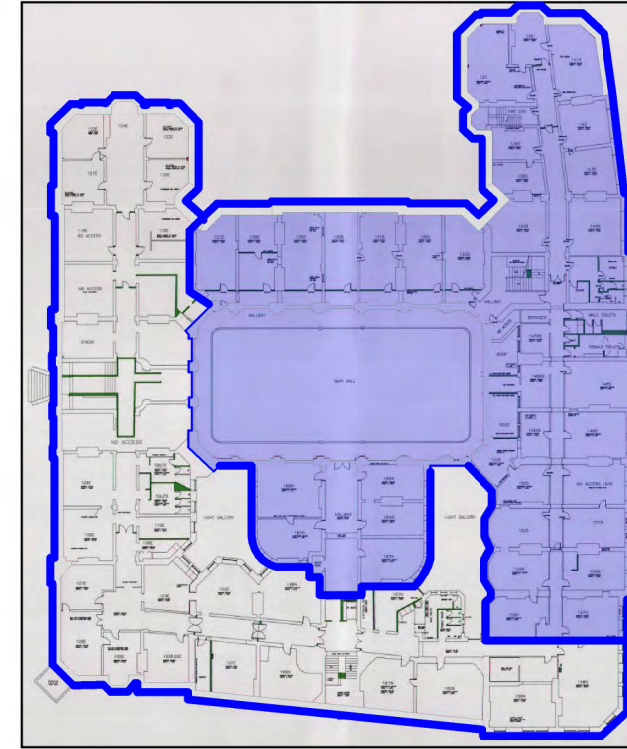
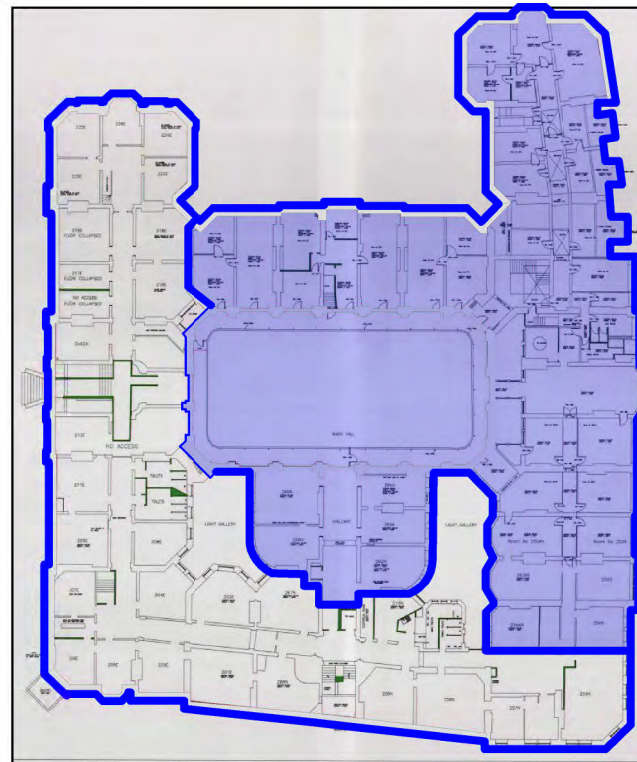
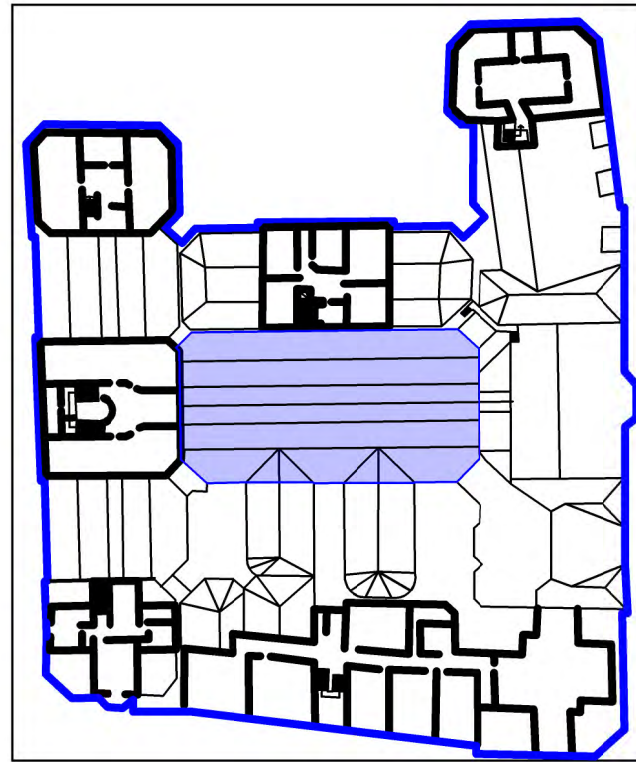
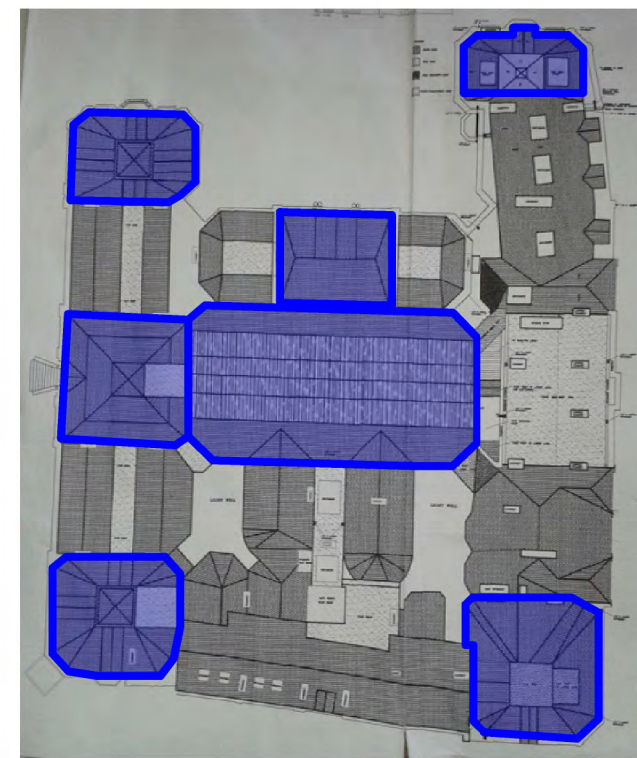
Areas retaining high levels of original fabric

Areas where most original fabric and character survive
